**Intermountain Power Service Corp.  
ABT Siemens Warranty Claim**

Unit #2 - 950 MW

Plant Location – Delta Utah

Date: October 17, 2007

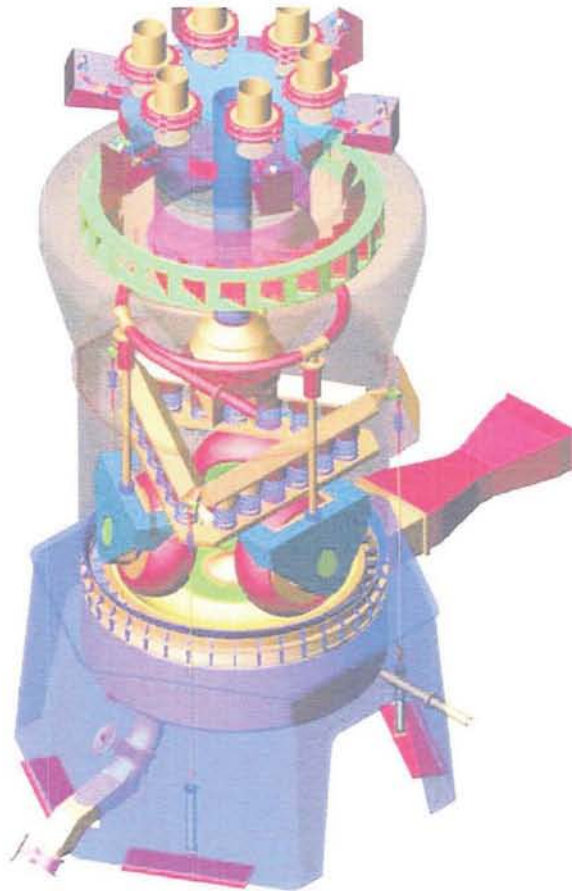
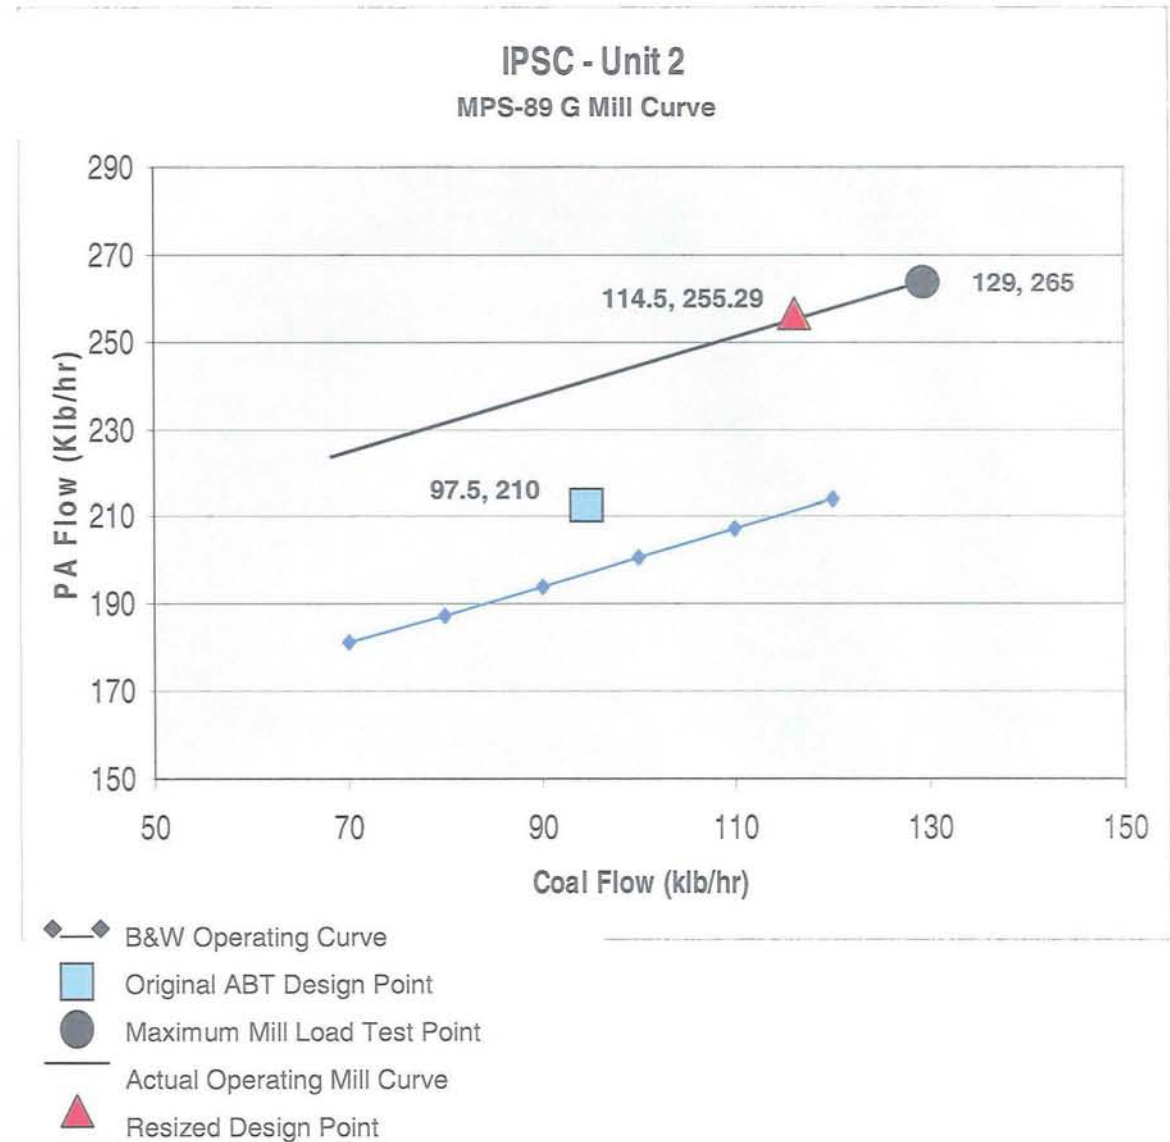
## Erosion and Mill Air Flow

The alloy nozzle tip cracking is the result of erosion of the wall thickness in the nozzle due to higher than original air and coal flow. The thinner wall section weakened the nozzle to the point that the nozzle could not accommodate the stress generated by the differential expansion between the stainless steel nozzle and the carbon steel barrel.

There is material loss at the burner nozzle tip, "X" vane at the coal pipe elbow and the burner barrel are a result of coal and air flows being higher than design plus stratification of the coal particles in the coal pipe entering the 90° elbow.
